Metal Braided Flexible Hoses

These common plumbing fittings are a ticking time bomb that can be found in almost any property.

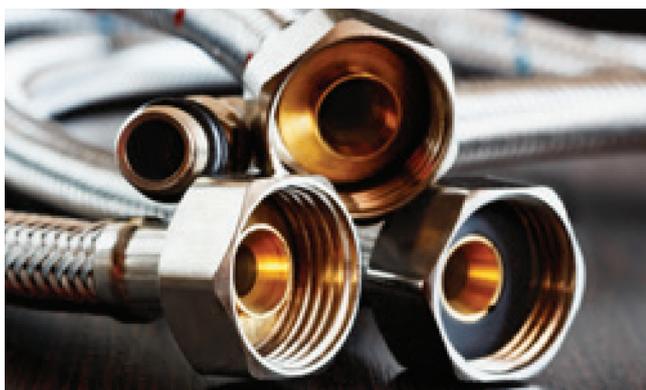
Hydraulic hoses, typically rubber or plastic, that are covered in a braided metal skin that provides additional strength and protection.

Metal braided flexible hoses first started finding their way into the domestic market roughly 20 years ago. They are generally used to connect sinks, basins, toilets, etc. to a water supply rather than more expensive hard piping connections.

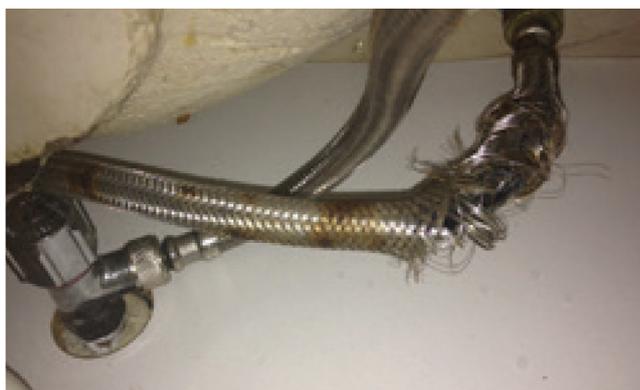
- the use of inferior (cheap) materials
- product selection and installation guidelines not being followed
- the hose is subjected to elevated temperatures and pressures (greater than 50 °C – common in many hot water systems)
- a lack of maintenance
- old age.

- Partial failure – a small hole/fracture occurs in the internal pipe wall with a small water leak penetrating through the external metal braided hose.
- Catastrophic failure – almost simultaneous internal pipe and external metal braid failure resulting in a near or complete and continuing water escape.

- Eliminate the risk – ideally, replace all metal braided flexible hoses with hard piping.
- Minimise the likelihood – replacement may not be practical in all cases. Proactive actions that can reduce the chances of the hose failing include:
 - ensuring product selection and installation guidelines are correctly followed
 - a regular inspection & maintenance program
 - a hose retirement/replacement protocol – preferably all hoses should be replaced before they reach five years of age.
- Minimise the consequences – even with the above risk management controls in place, hose failure may still occur. To help with swift isolation of the water supply a manual water supply closure valve that incorporates an auto reset flood stop mechanism can be installed on the upstream supply.
